Exhibit D1

Re: 82-88 Fulton Street
New York, NY
Block: 77 Lot: 24

As per your request, an interior survey of 82 Fulton Street was conducted on Thursday October 22, 2020 at approximately 12:00 pm in the afternoon. The building architect and lawyer was also present for the walk thru of all retail space. All, the retail space, are located outdoor, In an open arcade style layout, with a 3'-0" walkway, In front of the stores.

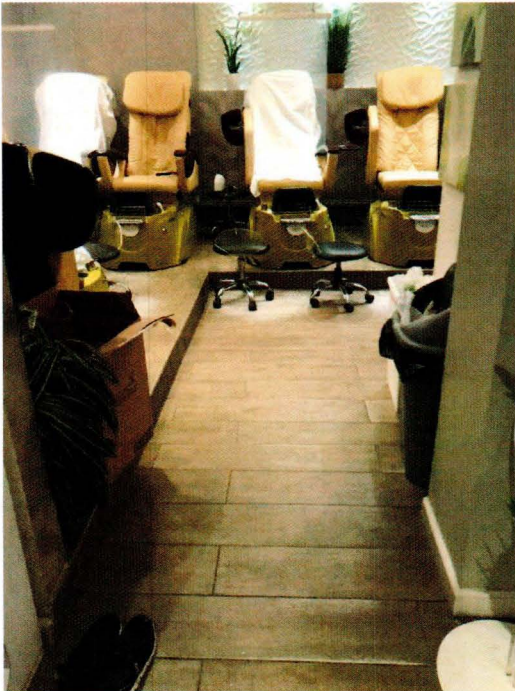
The first space which we walked thru was Affina spa, located at the corner of the building, on the first, floor level. The exterior, entry door, Is currently not ADA accessible, due to the temporary entry awning. Once the awning is removed, the entry should meet ADA approach requirement. The interior walk way of the space are fairly wide and meet ADA requirements for movement. There are two area which are not readily ADA accessible. One of the areas, In question, Is located on the left hand side of the space, next to the exterior window wall. The space consisted of a raised 6" high platform used for pedicure. The other space, which Is not ADA accessible, Is the public restroom. Due to the location of the door, in relation to the hallway, it is not ADA accessible. The approach to the restroom door is what we call a side approach. In this type of

approach, you need to have a clear hallway width of 42" min. Currently, the hallway is approximately 40", with an Inswing door into the restroom. Once inside, the restroom, the door would not be meet ADA requirement also. The door opens into a minor 40" x 30" hallway, then opening, up to a 62" x 64" restroom. In exiting the restroom, the door would be considered a frontal approach. In this type of approach, you need a clear space of 18" next to the door, which there Is currently does not exist. In terms of the

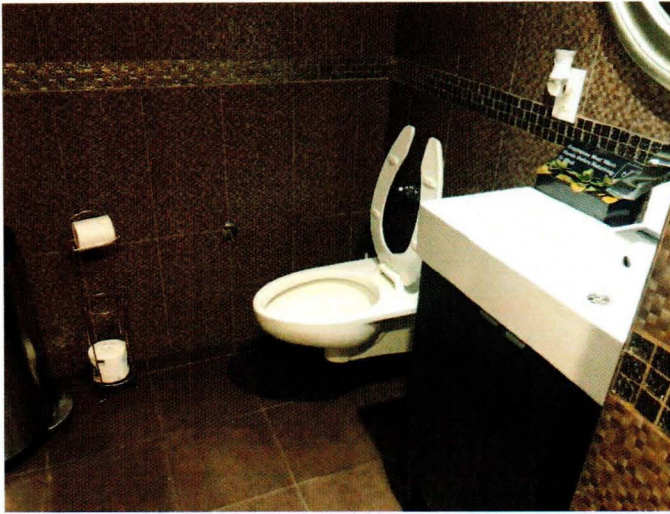
restroom, as per ADA requirement, a toilet needs to be located Inside a clear space of 60" x 56", with no other fixture within the space unless It Is a private toilet or a bathroom. Currently, there Is a lavatory within the required clear space, which does not meet ADA requirement. ``

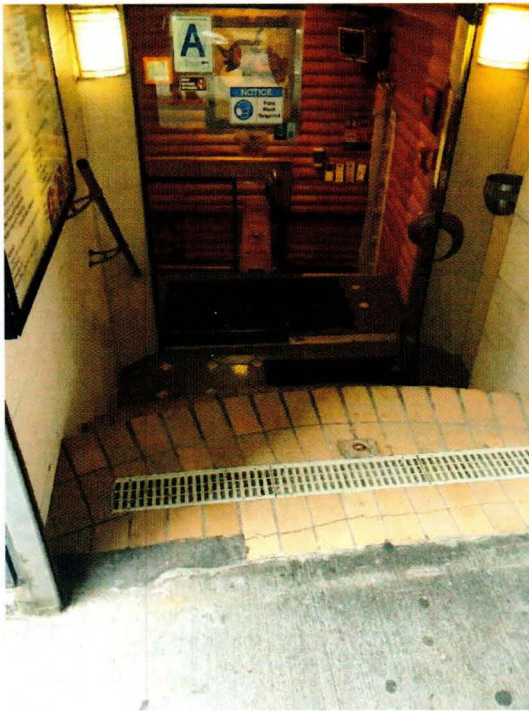
The next space which we looked at was a vacant Chinese restaurant. The approach, Into the space does not meet ADA requirements. Since the front entry door Is considered a

side approach, the walkway needs to be 42" wide minimum, but the current passageway or balcony Is only 36". In terms of the Interior, the space was vacant, with no public restroom or tables setup.

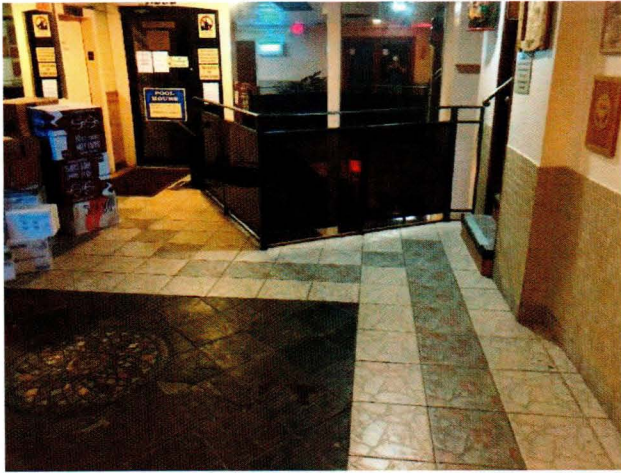
The third space which we visited was a Russian bath house or spa. The entry to the Spa was located on the ground floor street level, with the spa Itself, being located on the cellar and sub-cellar of the building. The spa Itself Is not ADA accessible, either from the sidewalk level or inside the space itself. Going Inside the spa, requires walking down three steps, from the sidewalk, onto a small exterior vestibule, then walking thru a pair of 36" glass door which swings out wards onto the small vestibule. Once Inside the space, there Is a 48" deep Interior vestibule with a staircase, going down onto the cellar level and Into, the main reception area. On the right side of the main reception area, there Is a stair with four steps going up, on to an open balcony passageway looking down onto the main sitting area located on the sub-cellar. At the end of the

balcony passageway, there Is a sitting area, which has another stair with two steps going up to taking you to another level and onto a second lobby area. Inside this small lobby area, there are two more staircase on the righthand side, with an elevator, at the front of the stair, that might take you up to the rest of the building. Management of the spa was not sure. In between the elevator and the stair was a doorway leading you onto the pool. One of the stairs takes you up to eight steps and onto a dining area,

located at another level. The second stair goes down onto the sub-cellar. On the left hand, side of the lobby was a pair of double doors, which takes you Inside a sitting room. Going down the stairs to the sub-cellar there was another sitting area and a lounge which opens, up to the passageway balcony above. At the end of the lounge, there was another vestibule or small lobby area which leads you to either the men's or ladies' restroom and locker room. At the corner of the lobby was a staircase

which goes up to the main reception area and the main staircase taking you out of the space. The whole Spa Is like a split level of different spaces. The rooms itself, are mostly ADA compliant, but going from one space Into, another Is not ADA compliant, due to the many stairs which you might have, to pass thru. The space In question Is capable of being modify to be ADA compliant, but It has to be study on a plan level detail.

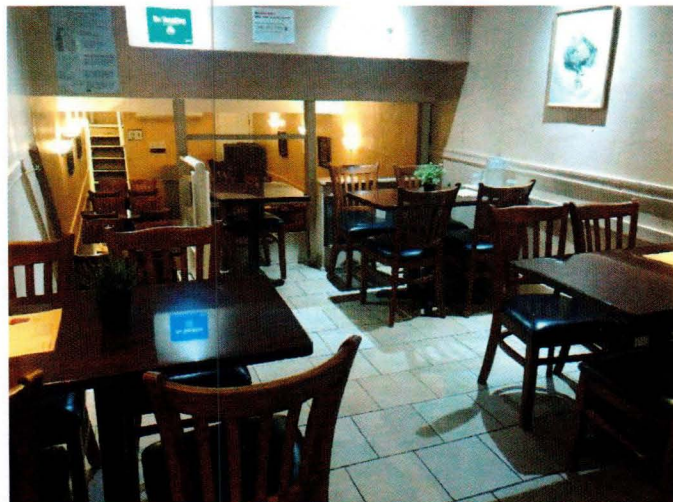
The fifth space which we looked at was an Indian Tandoor restaurant. Like the previous spaces, the approach going Inside the space are not ADA compliant, due to the exterior width of the walkway. Once Inside the restaurant, the front half of the dining area Is compliant while the rear and restroom are not. In order, for a person to reach the public restroom at the rear of the restaurant, you would need to walk down a stair consisting of four steps, from the front dining area, which bring you down to a non-ADA compliant dining area. At the rear of the dining room, there Is another set of stairs going up seven steps onto a narrow landing. At the end of this landing Is the door to a 3' wide x 7' long restroom, which Is not ADA compliant.

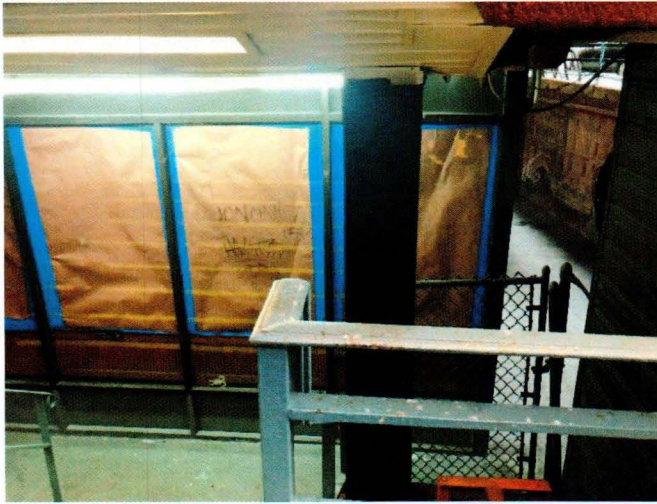
The sixth space which we looked at was a vacant retail space located on basement level

of the building. Like the other retail space, the basement level is not ADA compliant also, with access by stairs only. Since the space was vacant, an inspection of the interior was not conducted, since the ADA issue should be taken care of by any future tenant build out, when filing for work inside.

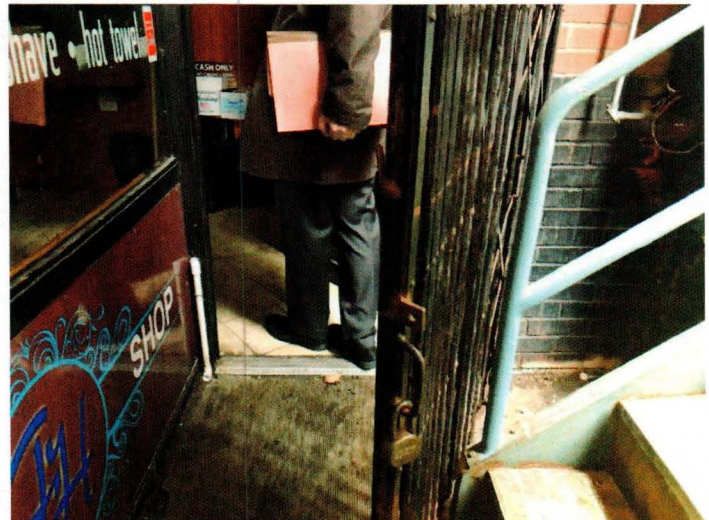
The eighth and last space is, located on the left side of the spa. To gain access to the space, you need to walk down one step, onto a small landing then down another step to the exterior vestibule of the space. The space, in question, was also vacant and empty with empty display case.

In reviewing all the retail space, each one is capable of being modified to accommodate the ADA issues. There are still rooms in the arcade to expand the walkway slightly to accommodate a side approach into each retail space. Once inside each retail space, there are rooms to accommodate any public restroom and walkway if required. Even the cellar spa is capable to be made ADA compliant, when the plans are properly studied and reviewed.
